Department of
Conservation
Te Papa Atawhai

Mountain Bike Track Maintenance in the Craigieburn Basin

To review the current maintenance of the multi-use trails in the Craigieburn Conservation area. Under a current Management Agreement between the Department and the Craigieburn Trails Committee (CTC) the tracks within this document (except for the Edge and Luge Tracks) are to be maintained by the CTC. As these tracks are on conservation estate the Department is to provide advice and direction where required, to ensure that the tracks within this agreement are maintained to an acceptable standard and continue to provide a safe experience for users.

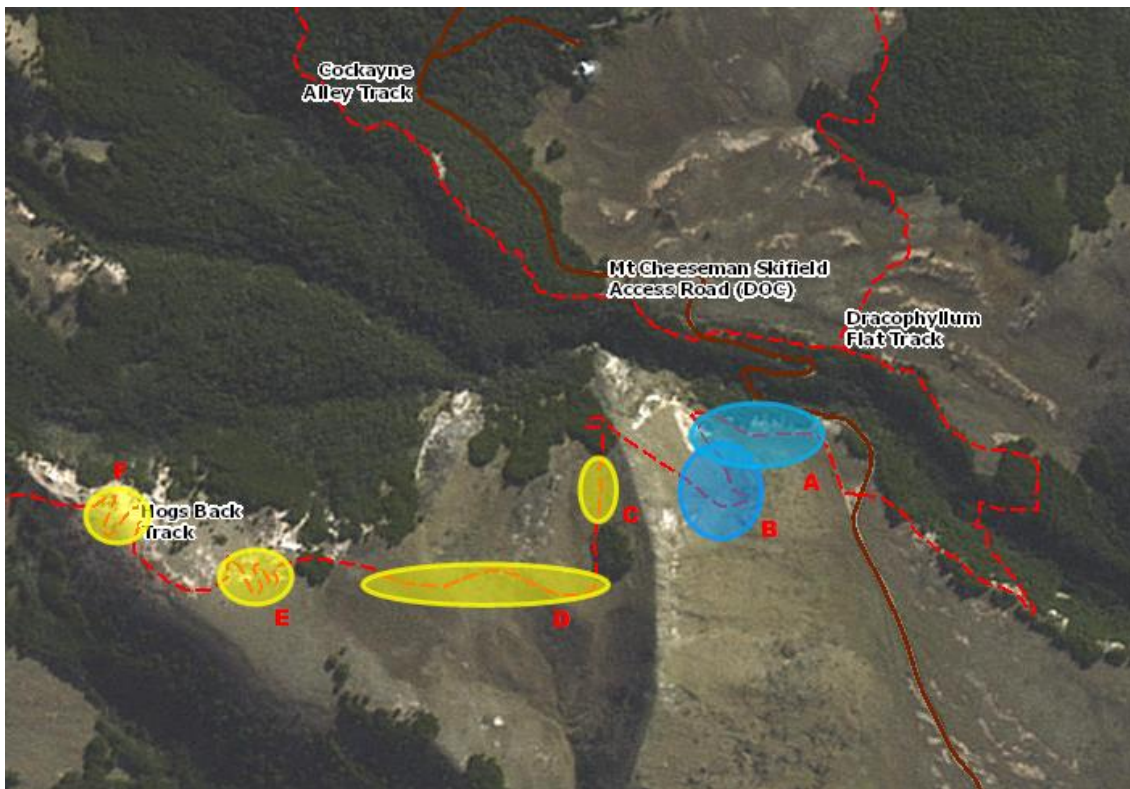
Proposed Hogs Back maintenance and realignments

These sections are in the alpine tussock and have become heavily eroded, with deep 'U' shaped ruts in many places. Water is unable to escape the track and in places double tracking is occurring. A mixture of winter use, soil and climatic conditions, track design and lack of maintenance has allowed these sections of track to deteriorate. Although there are some issues with track design, the overall grade for these sections of trail meet intermediate standard. Except for section C, major track realignment is not considered necessary, although minor realignment to incorporate such features as grade reversals should be considered.

- Given how susceptible these sections of trail are to erosion, imported material should be considered. The level and type of use, coupled with the soil and climatic conditions suggest that small scale maintenance work, such as patching up muddy spots, track widening, or cut and filling ruts, will not work in the long term. Imported material could be used to effectively 'fill in' the 'U' shaped ruts, harden the riding surface and recreate a level trail.

- Edges of the trail are to be removed to allow water to escape from the trail surface, rather than running down it.
- Each section requires the drainage to be assessed. Current track drainage is inadequate. Track features should include grade reversals, cross-sloping, and swales and may require some minor realignment to allow for better water management. Drainage points and track features are to be identified and flagged prior to any work proceeding.

- Realigning these sections should be investigated.
- It is possible to move section D to a more northerly aspect which would help with drying and would move the track away from a problem wet area.
- It is possible to realign the corners of section F to both reduce the gradient and open up the radius of the corners. This would help with water control and reduce the entry speed of riders, thereby helping to reduce maintenance and erosion issues.

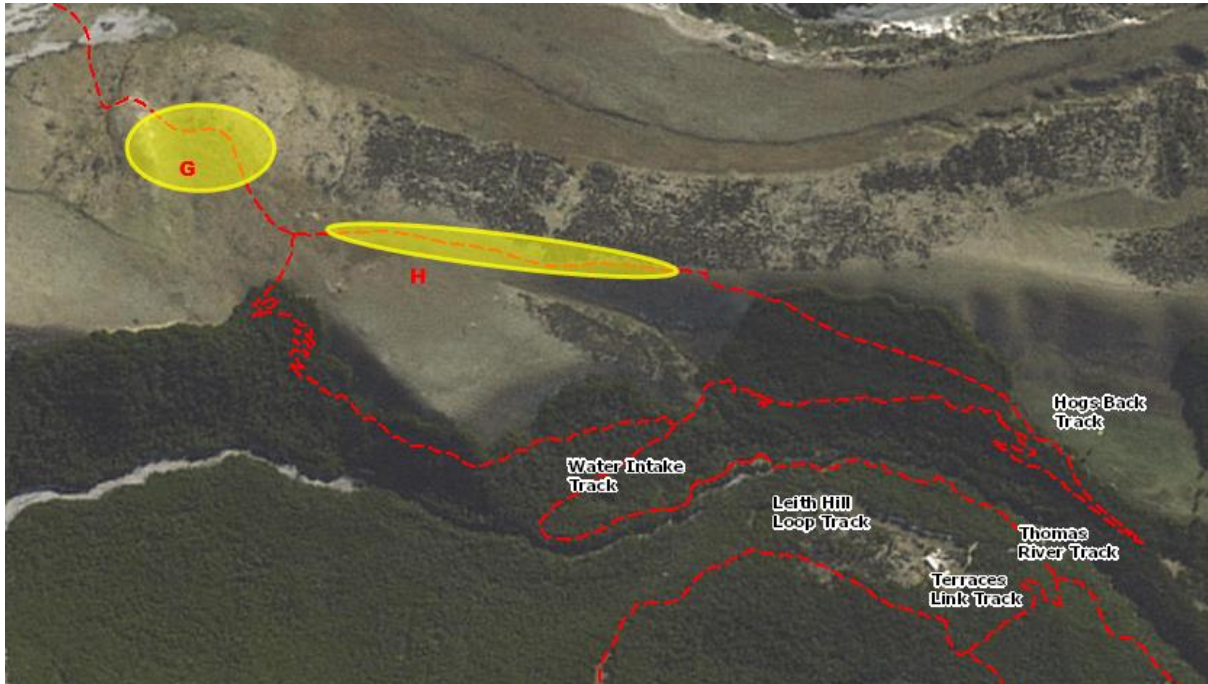
Proposed Hogs Back upgrades and realignments

Section G is the climb from the flats up to the lightning tree. This section follows an old 4wd track and is steep for the overall intermediate grade of the track. This section is also now showing signs of wear and water damage and is continuing to deepen as it erodes. Given the previous use and design of this track (old 4wd farm track) it is difficult to control water. Section H runs from the ‘Lighting Tree’ to the start of the final descent into the Castle Hill Village. This section utilised an old 4wd track when the Hogs Back was first constructed. A desire line has generally developed, although in a number of places the track is multi-tracked and wet sections can develop in the spring. The possibility for less experienced riders to get cross rutted is present although probably unlikely. More relevant is the diminished riding experience due to the multi-tracking and relatively straight nature of the track.

- That section G is realigned, and a purpose-built section of track is constructed to replace it. This will be constructed to intermediate grade and designed to be ridden in both directions. Realigning this track will both improve the experience for riders travelling in both directions and will reduce the long-term maintenance issues for the track.
- That section H is redesigned, utilising the general direction and line of the current trail, but adding features and flow to the trail to improve the riding experience and reduce any maintenance requirements on the track. Track construction and surfacing would be required.

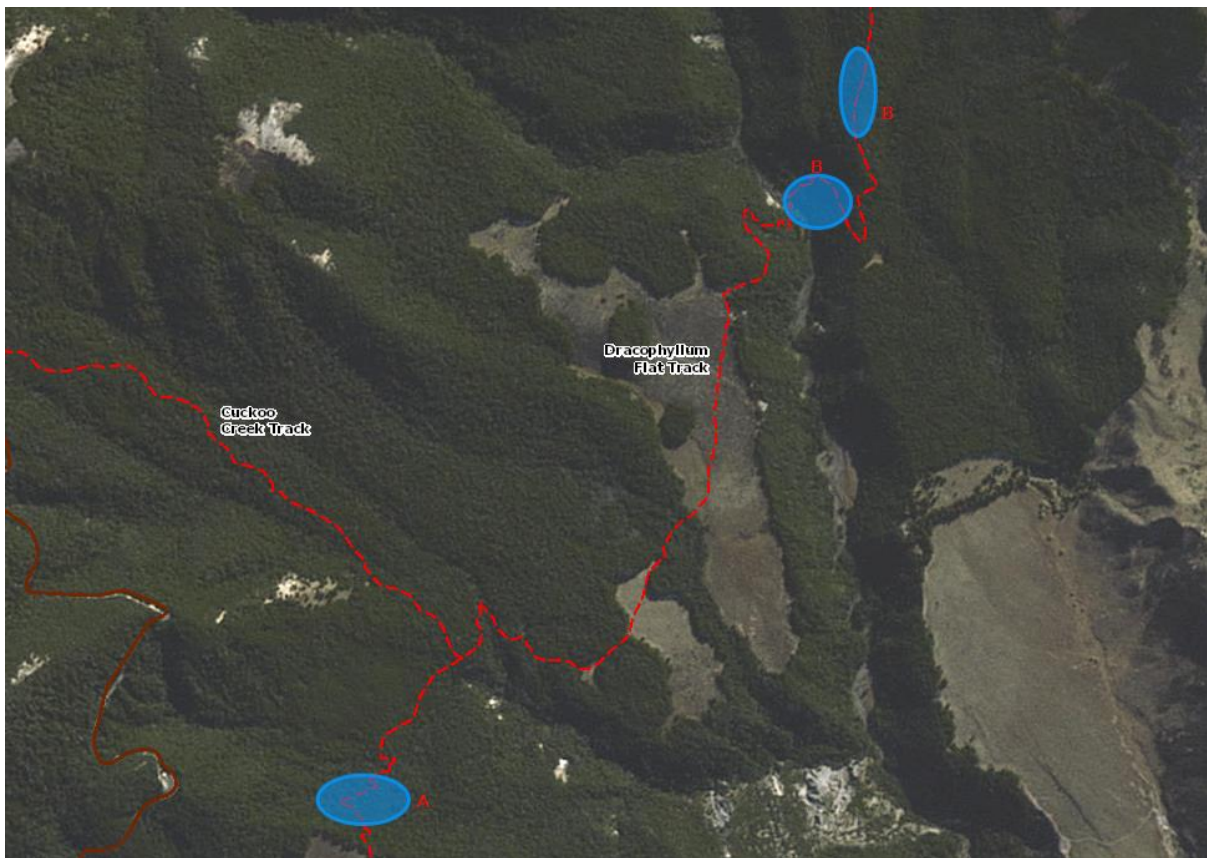
Proposed Dracophyllum Flat Track realignments

- From Jacks Pass the track generally descends down to the Broken River. This descent has variable and generally acceptable grades. However, there are 2 notable pitches towards the bottom of the track before the river. Both these pitches are above 20% gradient and are quite straight – presenting a challenging climb for intermediate riders, and high speeds/heavy braking and long-term maintenance issues from descending riders.

- That a possible realignment of sections of the track (section B in accompanying map) descending from Jacks Pass to Broken River is investigated.

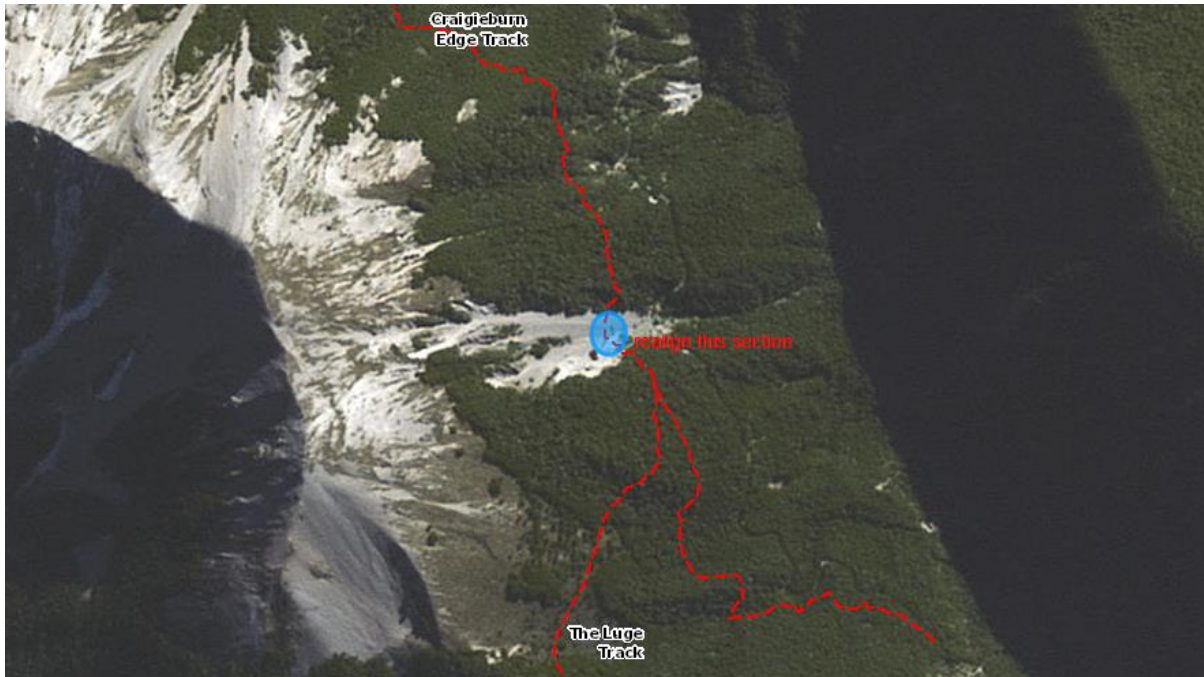
Proposed The Edge Track realignment

The track displays less wear than the Luge Track, perhaps because as a combination of less use, and fewer areas of heavy braking. However, in places the track footprint is narrower than the standards given for an advanced level mountain bike track and combined with the significant fall to one side can feel intimidating for some riders used to more room for error. Considering this, there are several areas along the track which require work to re-establish a bench of acceptable width.

- This track should be monitored annually for signs of increased wear.
- There are a number of areas along this trail where the trail width is unacceptably narrow. These areas are to be highlighted and rebenched to a minimum width of 400mm and up to 600mm where possible.

- There are sections along this trail where horizontal widths appear marginal and could cause a rider to clip a bar and crash. These areas are to be highlighted with a DOC advisor and rectified.
- To improve the riding experience, it is recommended that one section of scree crossing is realigned to prevent riders from having to dismount (refer to following map).

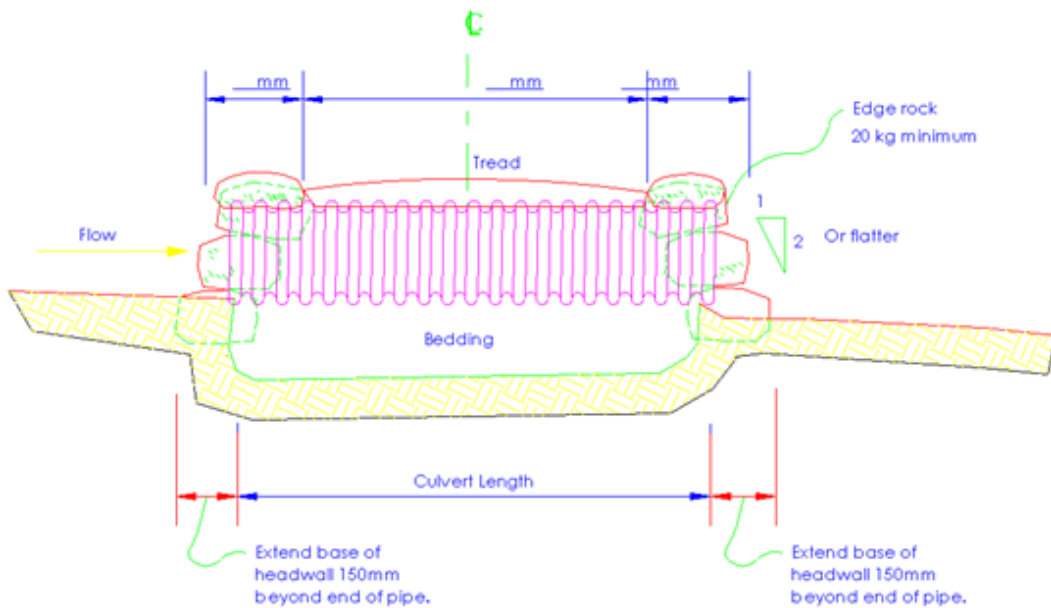
Note -this example used ribbed piping, which is not recommended in the Craigieburns. The ribbing will catch material such as beech leaves causing the to clog. Smooth pipes should be used
