Department of
Conservation
Te Papa Atawhai

Mountain Bike Track Maintenance in the Craigieburn Basin

To review the current maintenance of the multi-use trails in the Craigieburn Conservation area. Under a current Management Agreement between the Department and the Craigieburn Trails Committee (CTC) the tracks within this document (except for the Edge and Luge Tracks) are to be maintained by the CTC. As these tracks are on conservation estate the Department is to provide advice and direction where required, to ensure that the tracks within this agreement are maintained to an acceptable standard and continue to provide a safe experience for users.

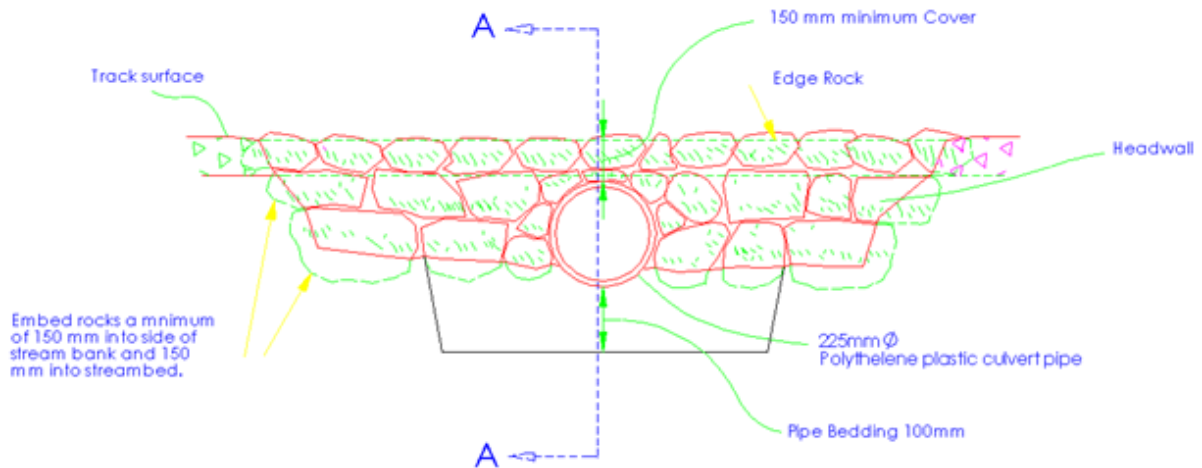
- Example of culverting with rock headwall

Note -this example used ribbed piping, which is not recommended in the Craigieburns. The ribbing will catch material such as beech leaves causing the to clog. Smooth pipes should be used

Headwall rocks:
20 kg minimum,
50% larger than
30 kg
